TWO STAGE POTASSIUM TEST TURBINE

QUARTERLY PROGRESS REPORT NO.13

For Period : May 8, 1964 Thru August 8, 1964

prepared for
NATIONAL AERONAUTICS AND SPACE ADMINISTRATION
CONTRACT NAS 5-1143

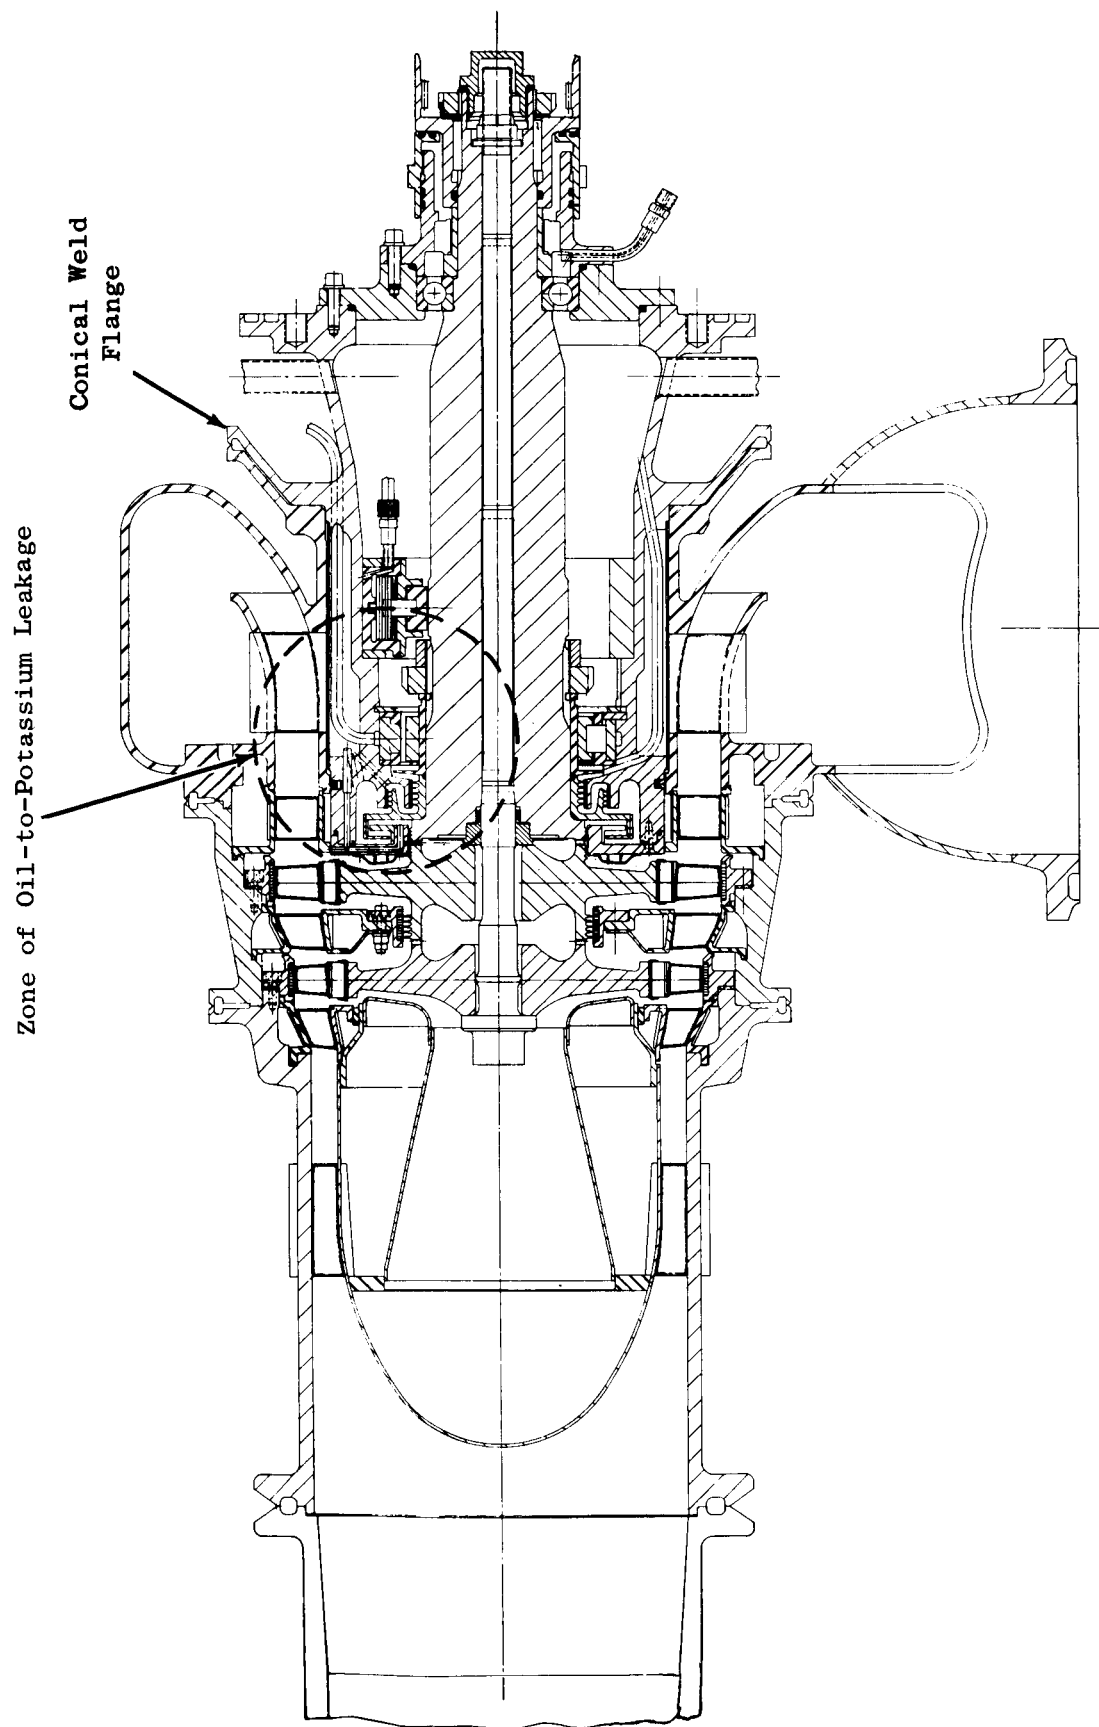
Figure 10. Potassium Turbine Assembly Drawing Showing Zone of Oil-to-Potassium Leakage

During the first phase of potassium testing in the Building 318 turbine test facility, on April 13, 1964, with potassium in the slinger seal, argon in the buffer seal and lube oil for the bearings, severe mixing of fluids was experienced. Considerable amounts of potassium were found throughout the lube system after damaging the silver plating of the pad bearings and the electric wiring of the pump motors. Large amounts of lube oil were found in the potassium seal loop, contaminating the loop and tanks, and rendering the EM pump inoperable. Some oil was found in the turbine loop.

Following the close analysis of the Sanborn and multipoint charts, showing no obvious correlation between the speed reduction and the recorded data, the rear turbine plate was removed to investigate the condition of the bearings. They showed no indication of damage. However, the screw seal immediately forward of the pad bearing had been severely rubbed. The next steps involved the complete removal of the bearing housing by cutting the conical welded flange where the housing and scroll are attached (Figure 10)

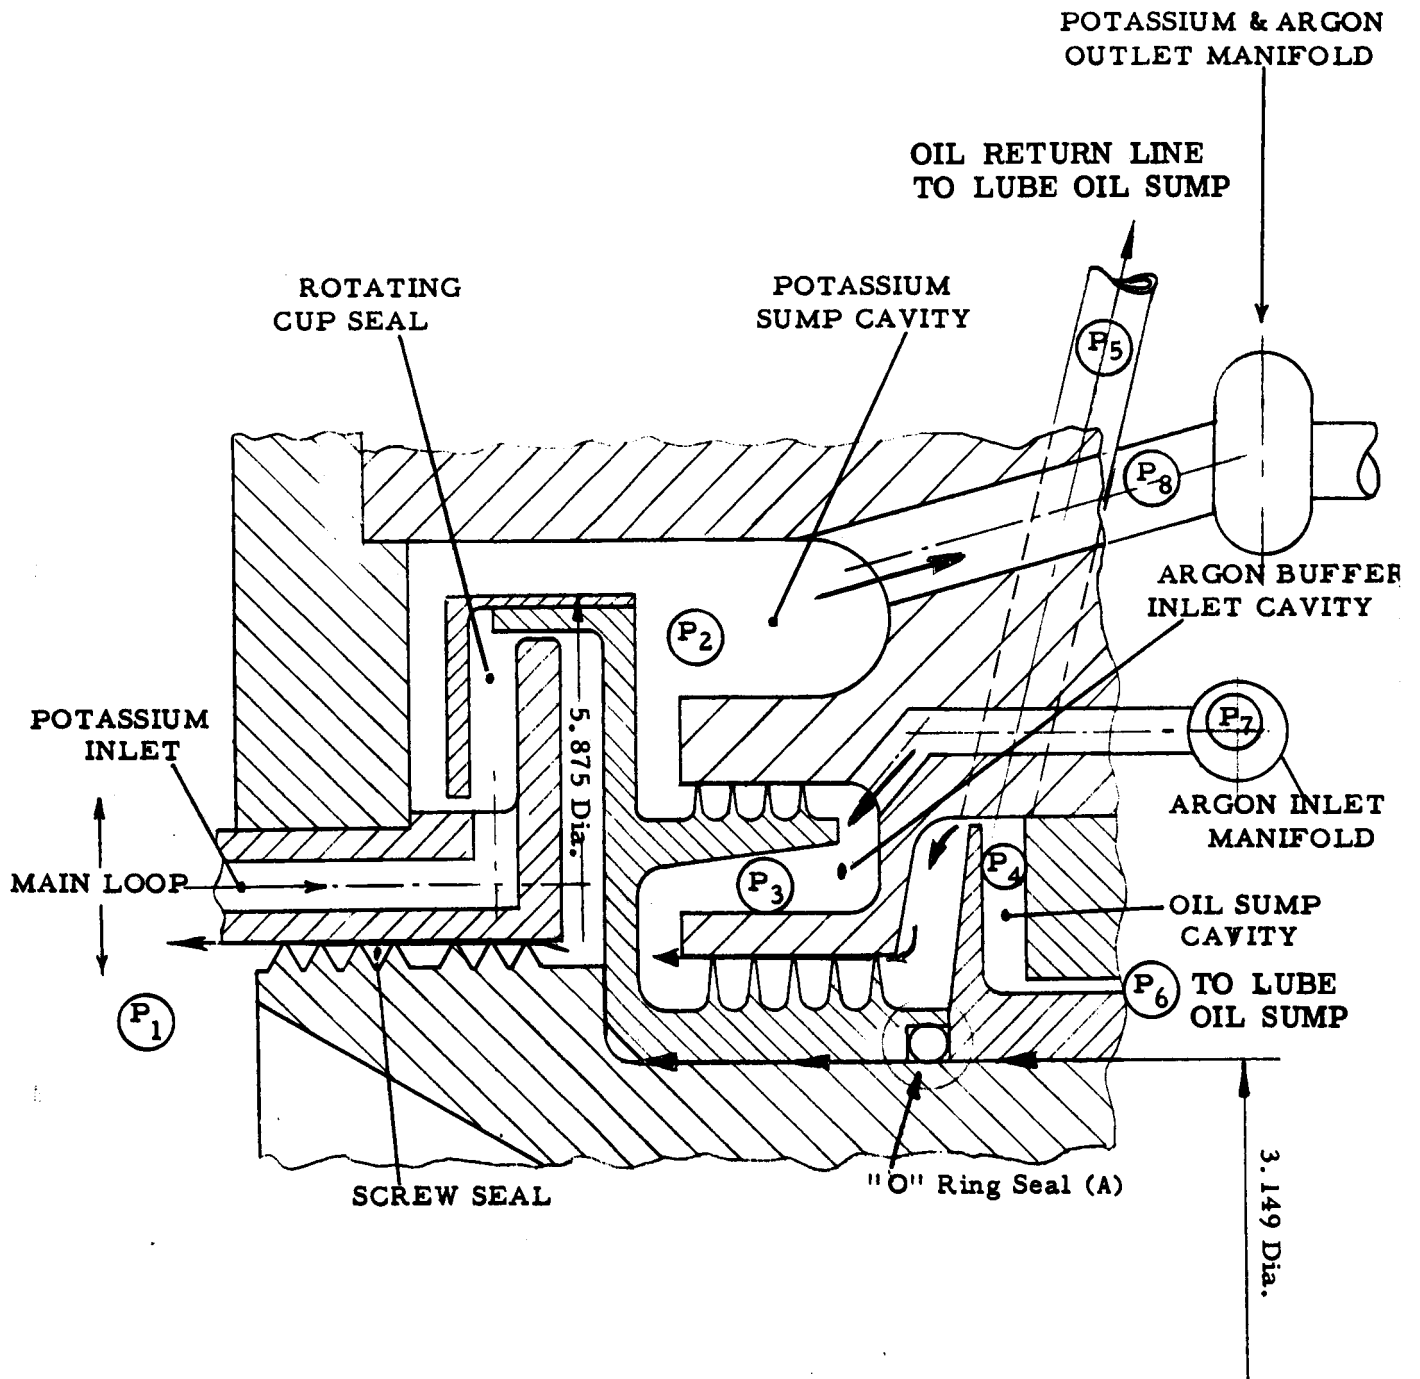
Figure 11. Sketch of Turbine Seal Assembly

What caused this to happen? What was so different in pretesting and potassium testing? What has to be done to make the seal fail proof? Following is a listing of observations made and measures taken. For completeness and understanding, some items are repeated, which were reported in the Quarterly Progress Report No. 12. A schematic of the seal region and its cavities is shown in Figure 11.

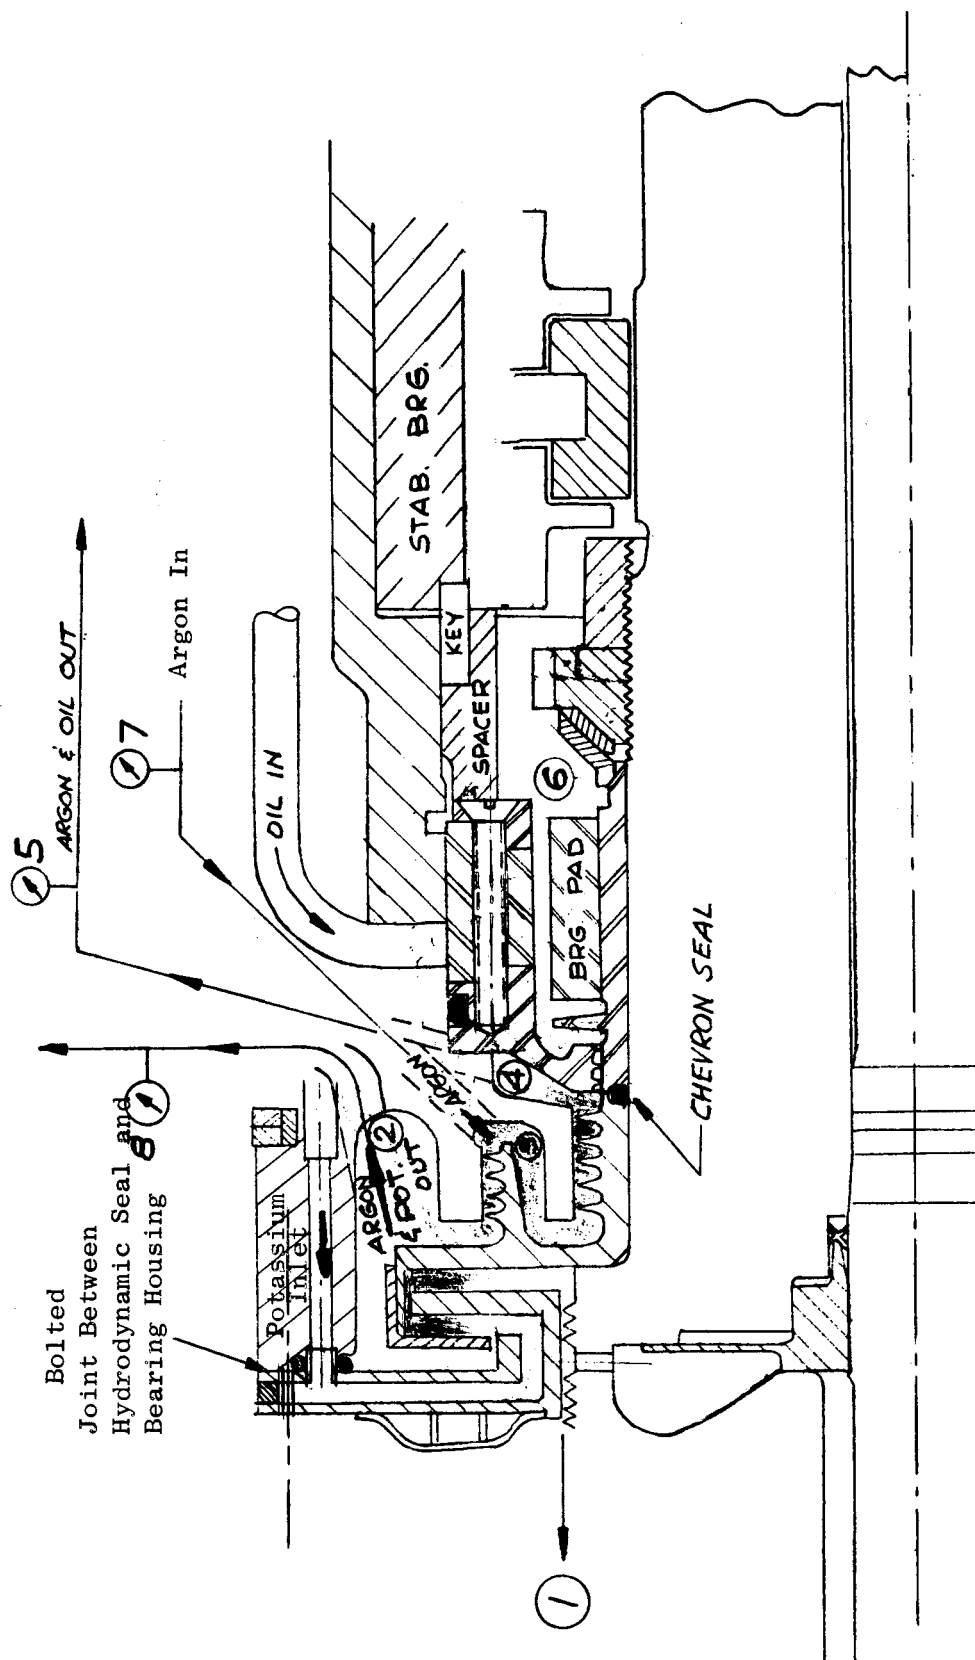
Figure 19. The Location of the Pressure Readings during Potassium Test

In addition to the speed fluctuations, evidence of leakage in the potassium inlet line to the hydrodynamic seal was observed by a continuous depletion of the reserve tank supplying potassium to the seal. This potassium was leaking directly into the main loop, at a rate which required the three gallon seal supply tank to be refilled about every fifteen minutes (by transferring potassium from the main supply tank). This seal leakage (which was immediately suspected to be at the junction where the hydrodynamic seal is bolted to the bearing housing and at which point the potassium inlet flow must bridge, as shown in Figure 19) appeared to

become progressively worse with time. Potassium bridges this joint through a short "transfer tube" and the joint is sealed with metal O-rings, but both were apparently leaking.

The problem of potassium leakage from the inlet to the hydrodynamic seal is being solved by an all-welded construction. A design is in process, which eliminates slip-joints and bolted configuration in attachment of the seal to the housing, or in the inlet potassium flow line.

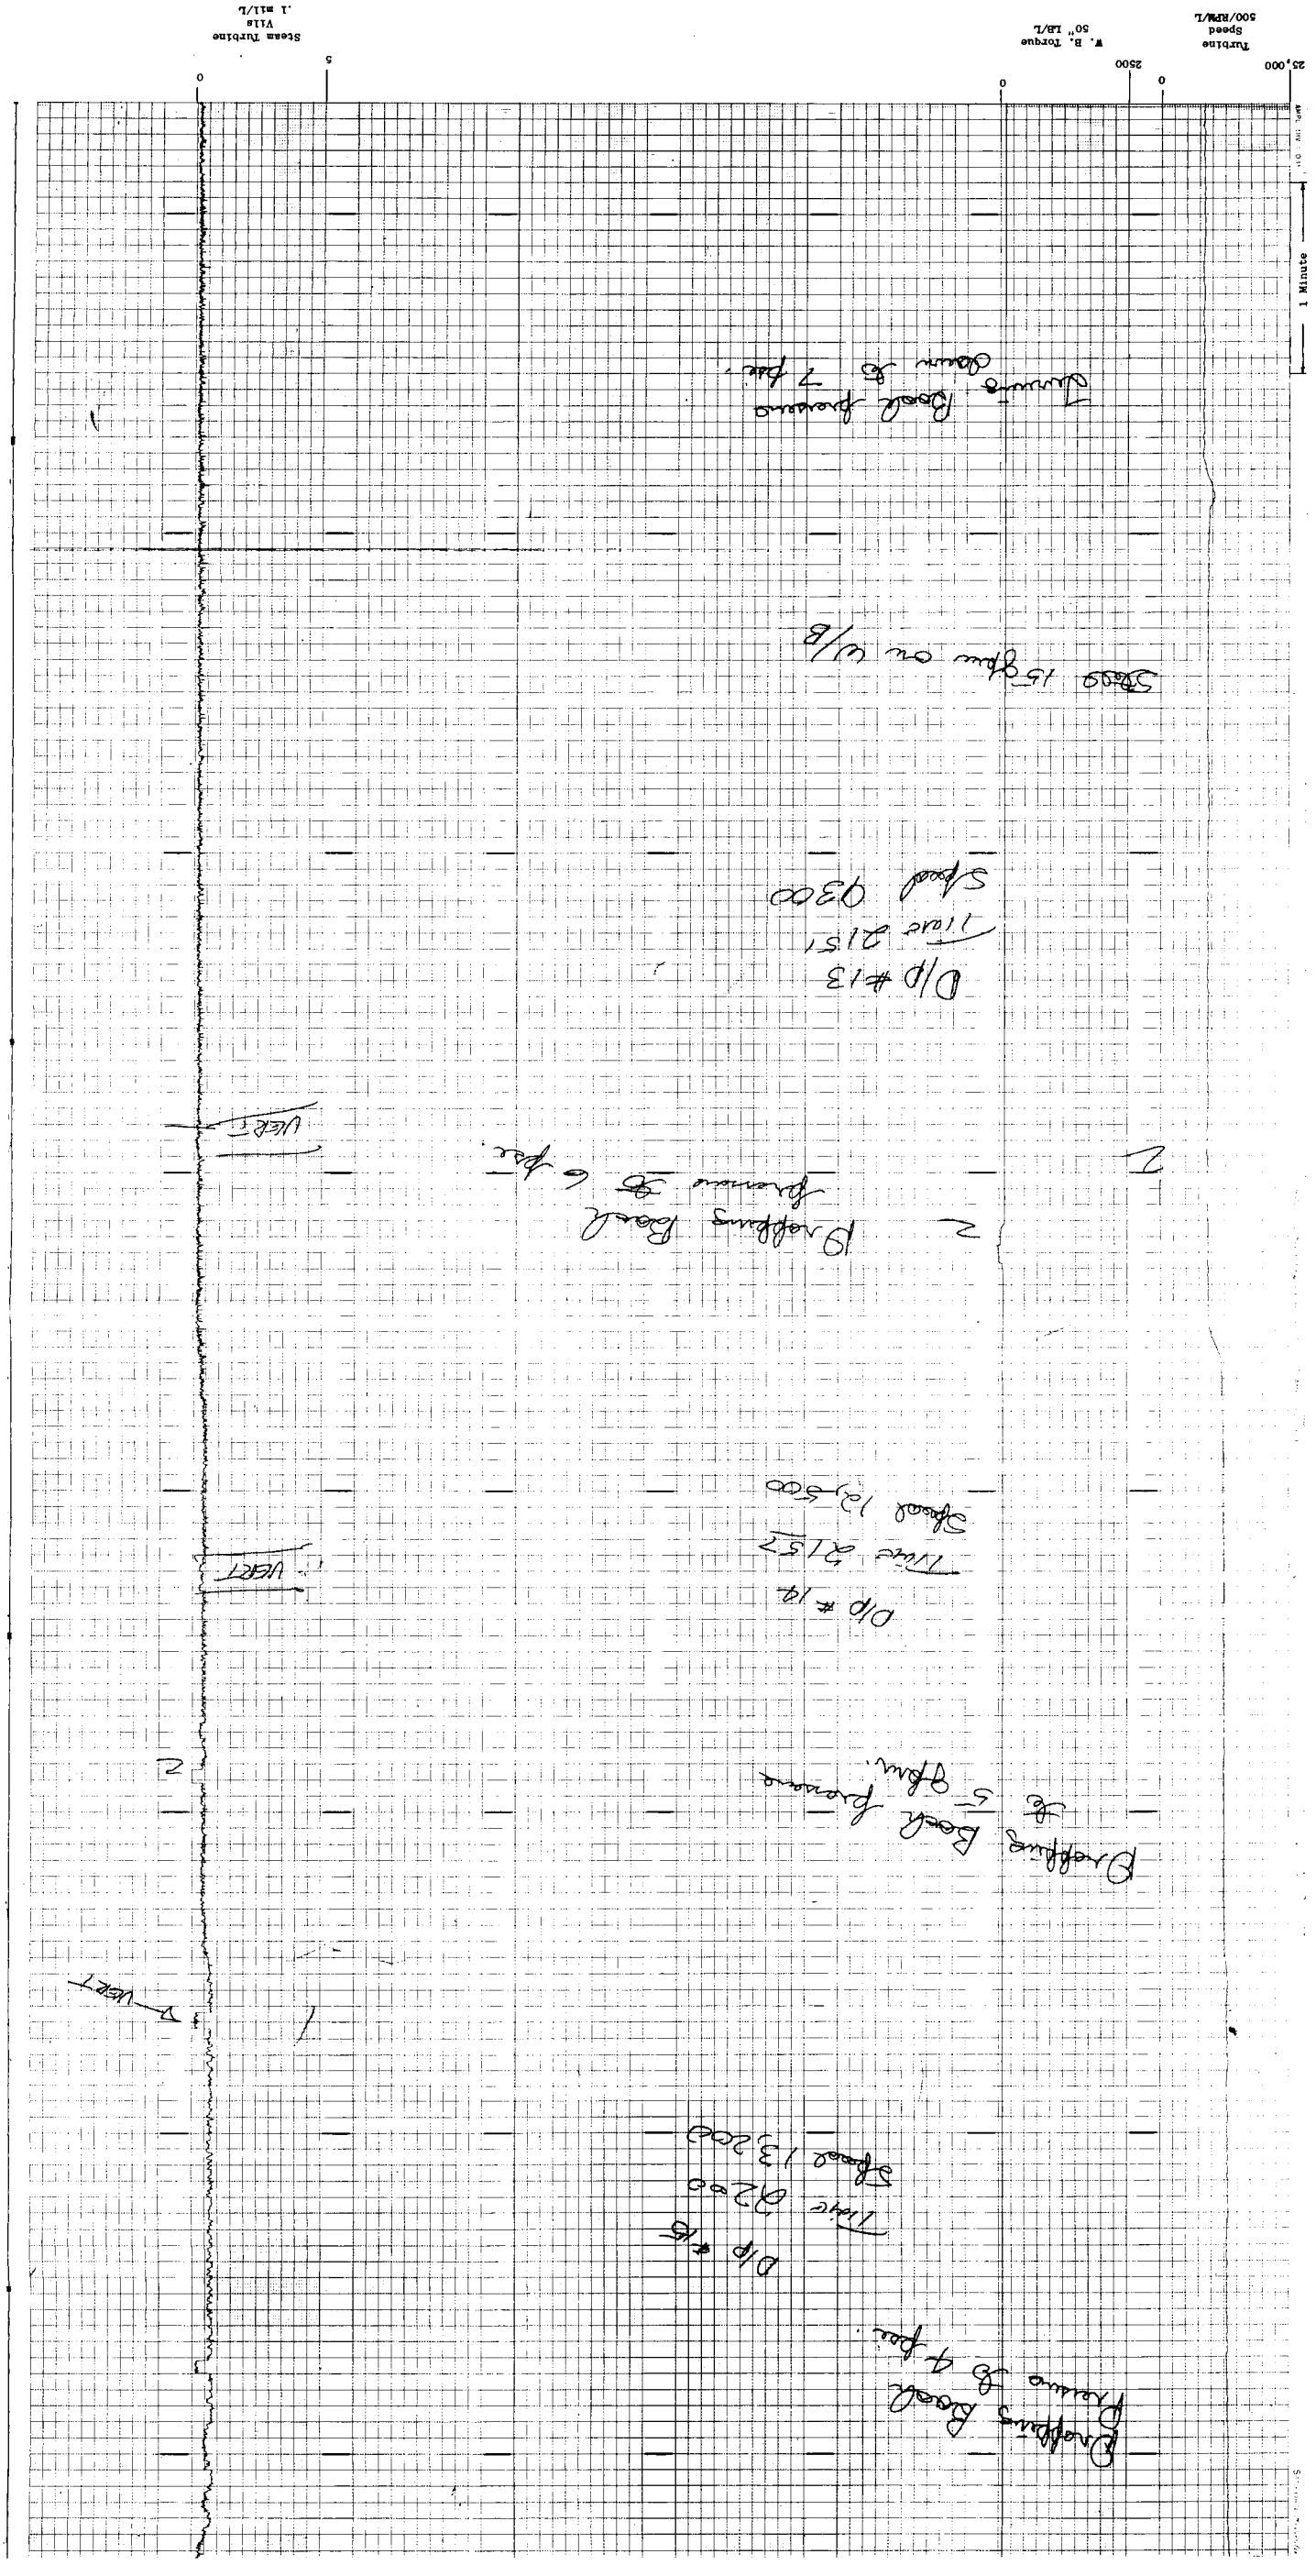
Figure 20. Sanborn Trace of Test on July 14, 1964 Showing Typical Speed.

During the above testing, while sharp speed excursions were being experienced, minor fluctuations in speed were suspected to have been caused by inferior control of the water brake. For this reason, a speed stability test was run in which the water brake, driven by the steam turbine, was operated under various combinations of flow, and control valve settings. It was suspected that during previous testing, the exit water brake line (which discharged eight feet below the brake) was producing a "siphoning" action, thereby causing surges in the flow and possible the minor speed fluctuations. During this test, the water brake exit valve was used as a control device and various speeds, and flows were run with the brake to observe stability and obtain a feel for speed control operation. The test revealed smooth speed operation as typically indicated in Figure 20.

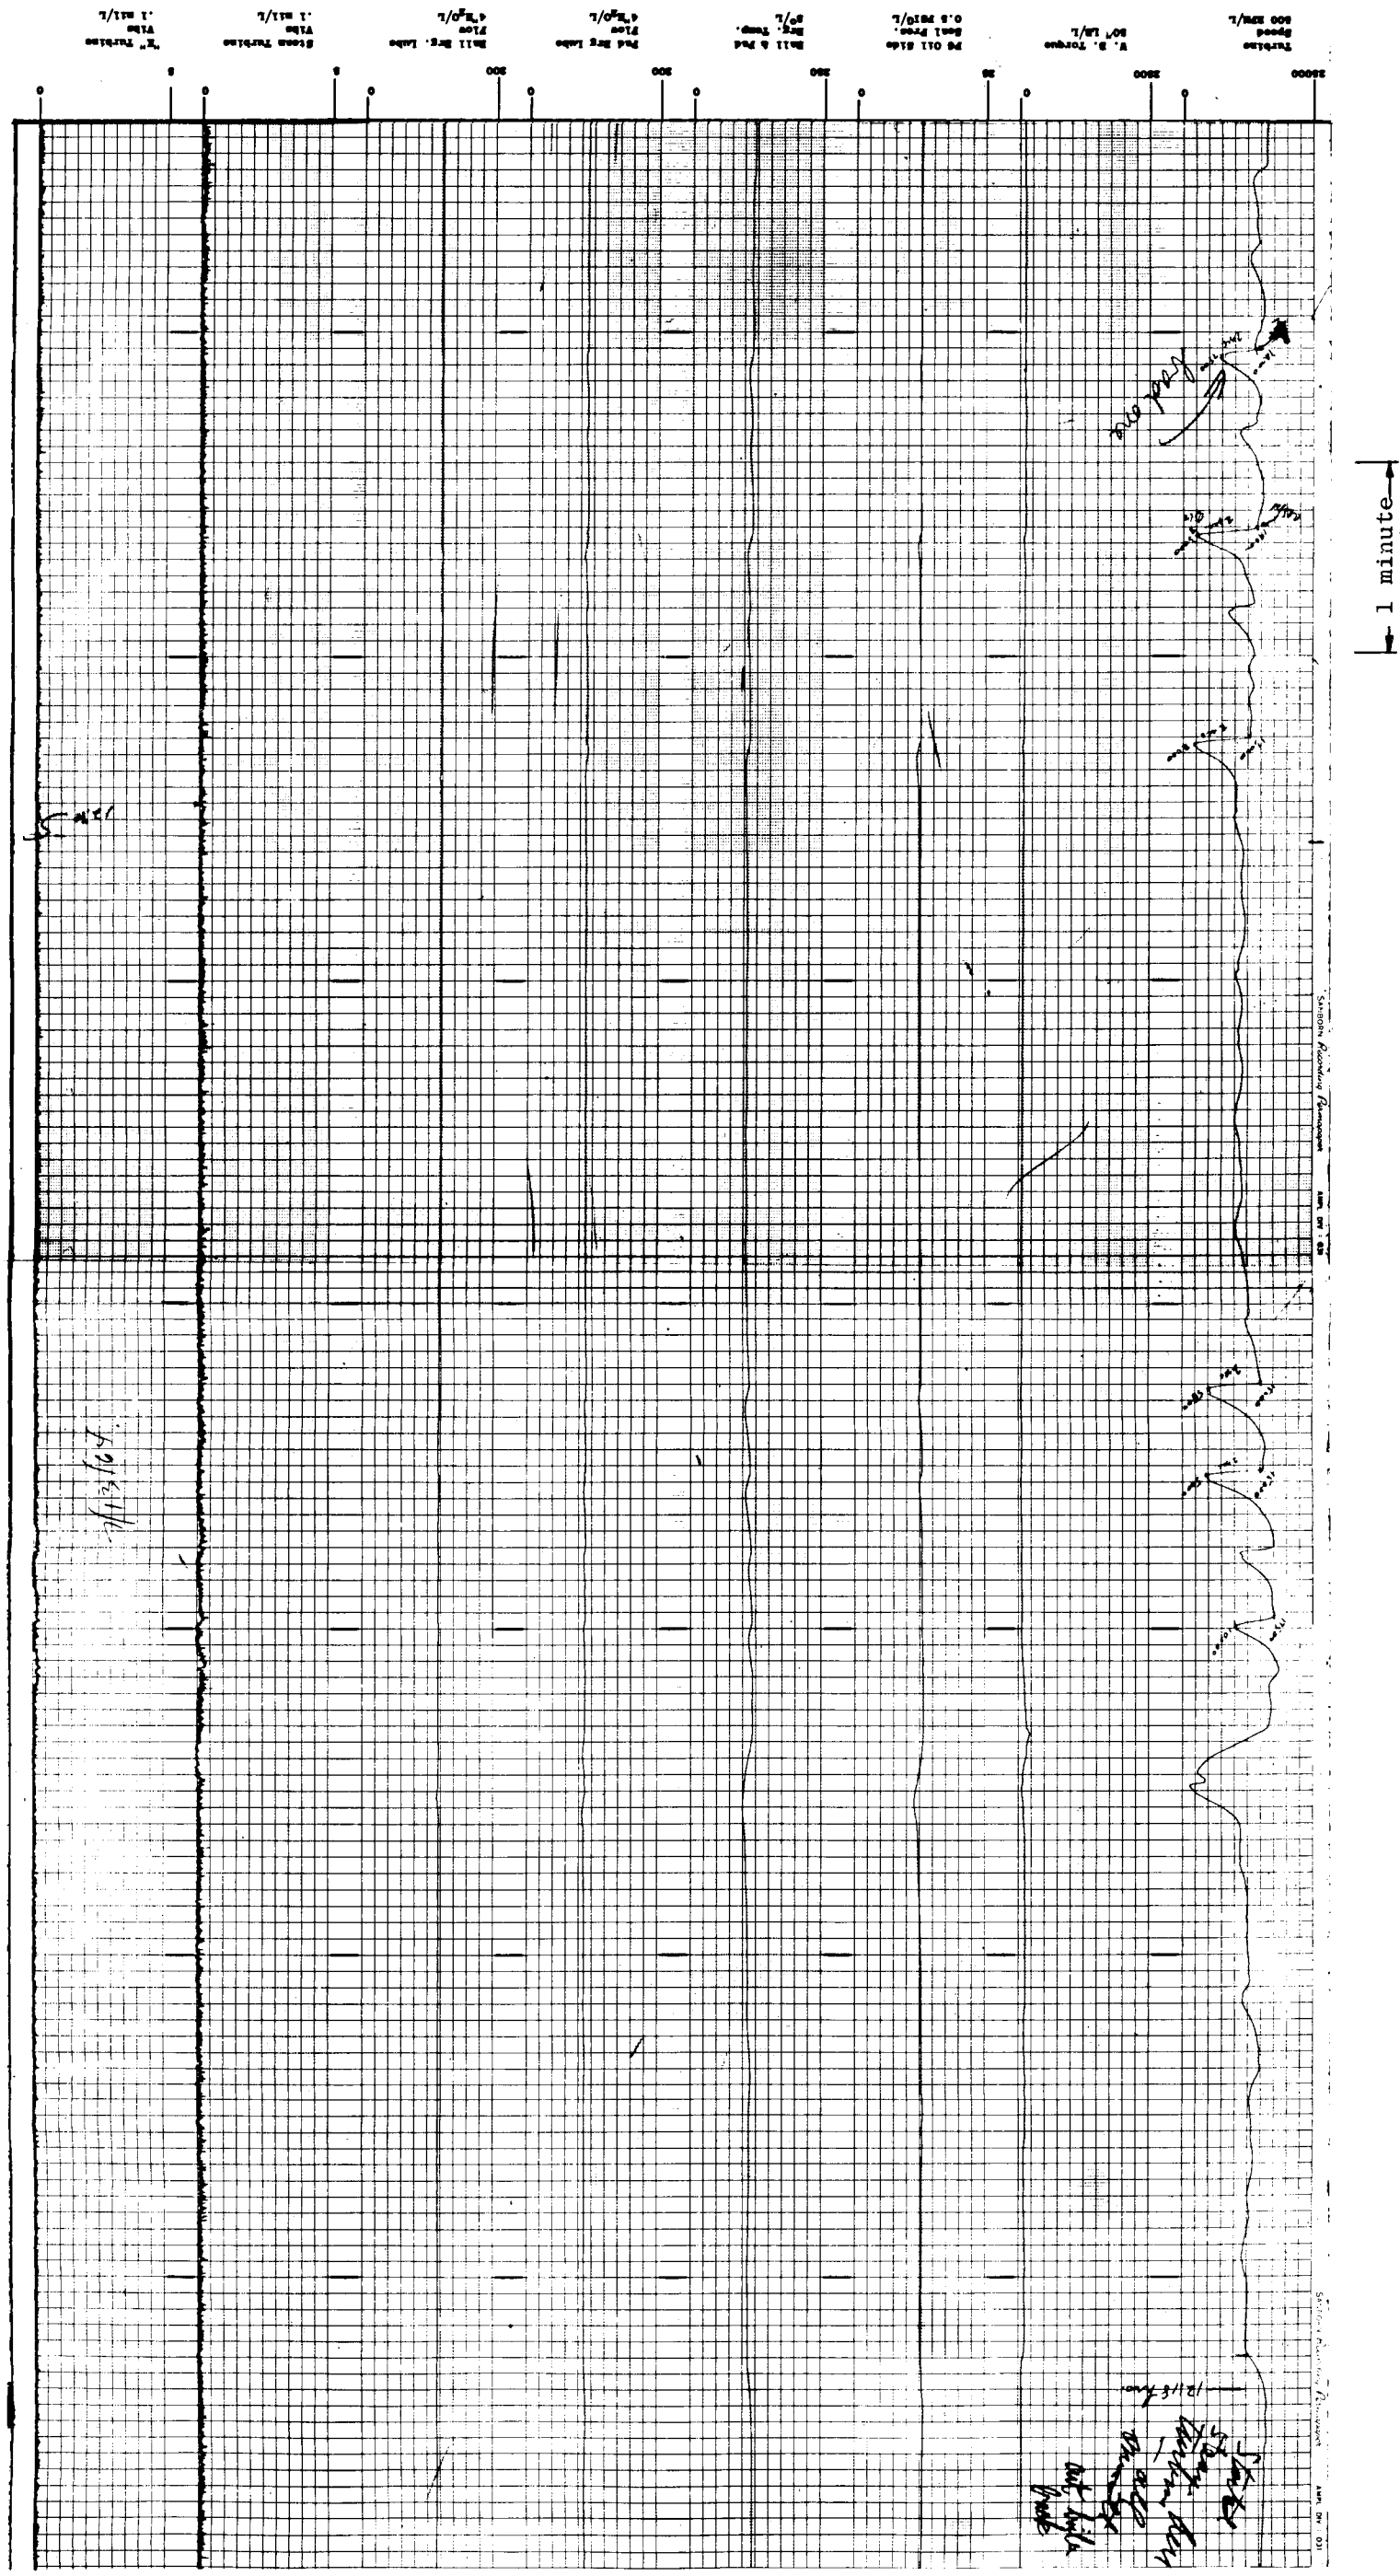
Figure 25. Sanborn Trace of Test on July 13, 1964 Showing First Flow of Potassium Vapor into Turbine

Figure 25 is a Sanborn tracing showing the turbine operating conditions during the first introduction of potassium vapor into the turbine. The turbine speed is approximately 15,000 rpm, and somewhat unsteady at this transient flow condition. The turbine output torque is low, and steady. The turbine bearing loop flows and temperatures are steady and vibrations are low, as they remained throughout the test. The speed trace shows operation up to the first downward speed excursion, closely followed by two more. Close inspection of the loop pressure data (shown on a separate Sanborn chart) shows that these speed dips are immediately followed by a rise in main condenser pressure level, due to the loss of the hydrodynamic seal with each speed drop, and the corresponding leakage of argon into the main loop from the turbine labyrinth seal. As can be seen on the Sanborn, no other significant perturbations in flow, temperature, vibrations, accompany these speed fluctuations. After undergoing eight such speed dips, the main vapor was shut off, and the turbine speed was maintained by the steam turbine. The Sanborn tracing shows that at this time, the speed became smooth and quite steady.

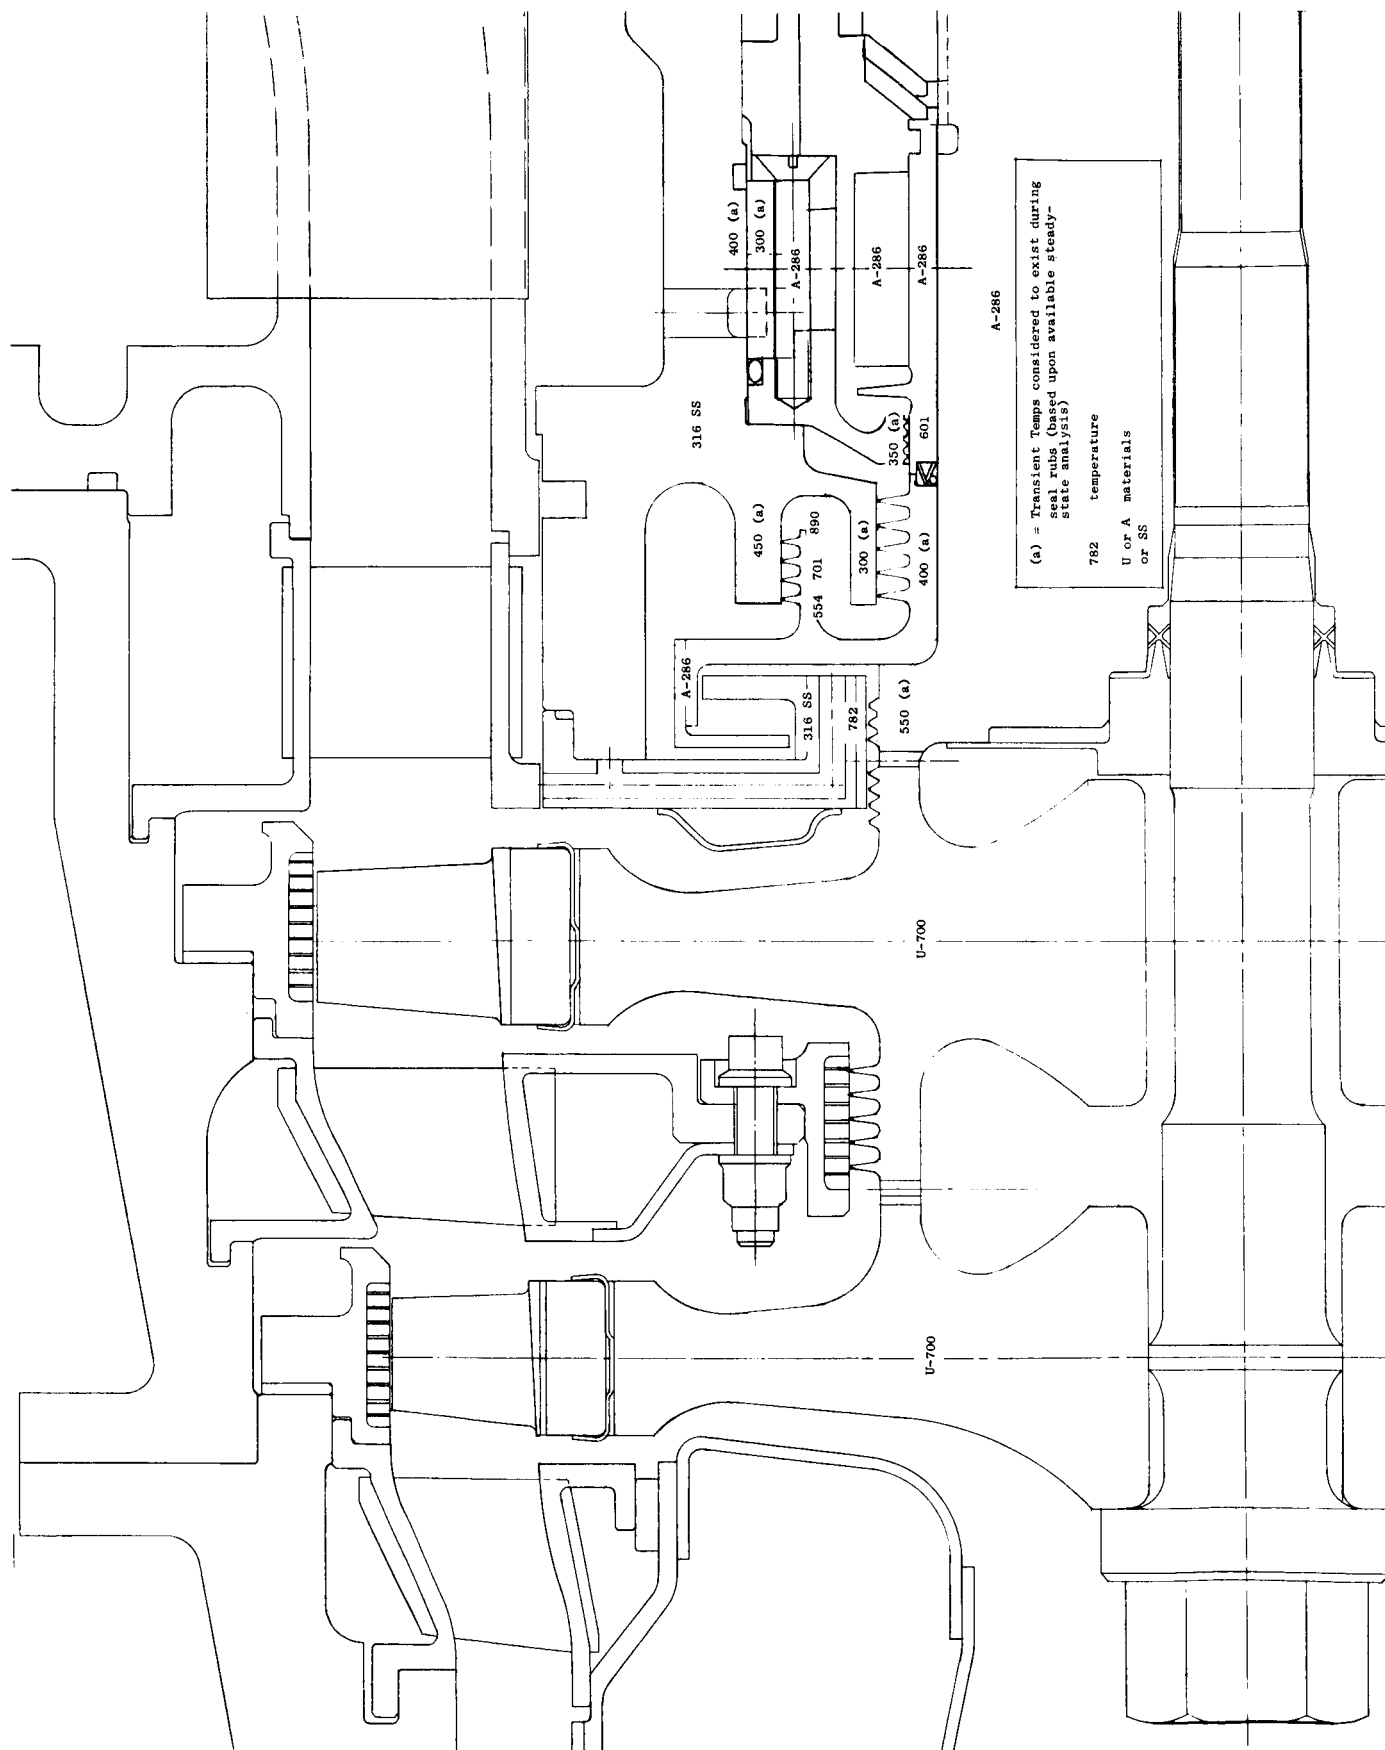
Figure 32. Assumed and Calculated Part Temperatures During Seal Rubs.

condition, the present analysis was based on what appeared to be the turbine temperature distribution during the conditions when the rubs actually occurred.

Because the inner labyrinth seal teeth had barely touched the mating rubbing surface, but had not worn away, the radial excursion of the shaft from its true centerline could be determined. Then with some assumed temperature levels throughout the turbine (based upon the design-point steady-state temperature analysis) the remaining temperatures necessary to produce the measured interferences could be calculated. These are shown in Figure 32. Assumed temperatures are indicated as such. Materials and coefficients of expansion are given.

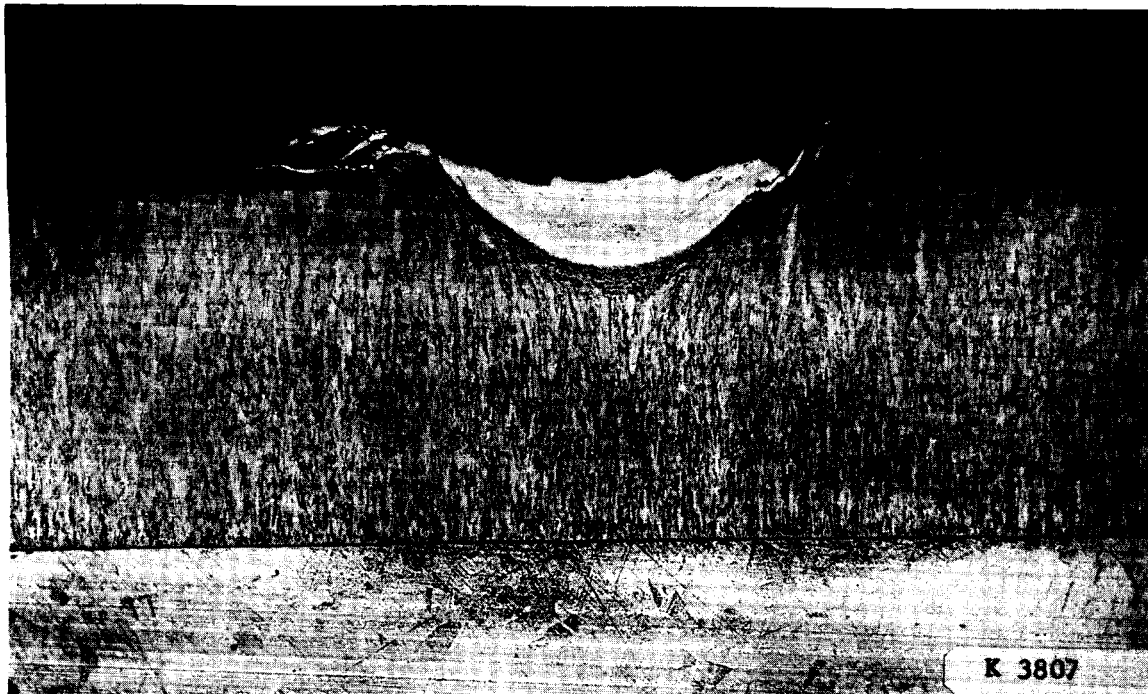
Figure B-3. Nickel Electroplated Rub Specimen, Annealed, Showing Shallow Rub Groove, 50X (K 3807)

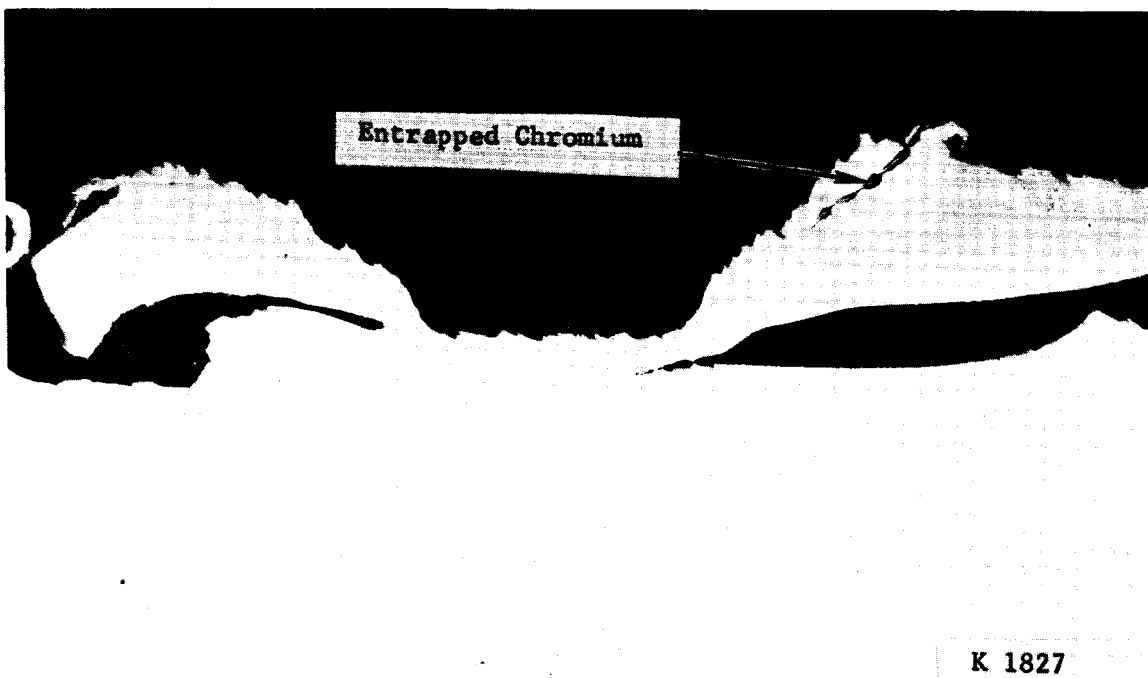
Figure B-4. Copper Plated Rub Specimen Showing Entrapped Particle of Labryinth Teeth Chromium, 50X (K 1827)

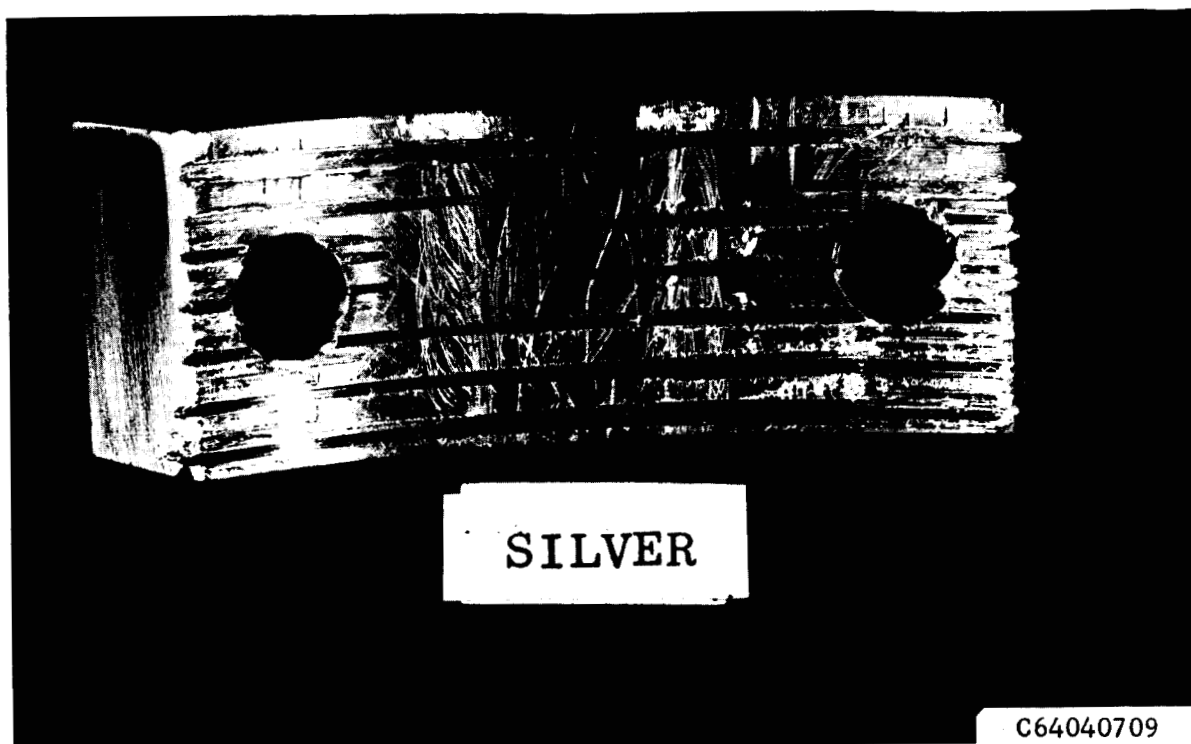
Figure B-5. Silver Electroplated Rub Specimen After Two Labryinth Wheel Contacts (C64040709)

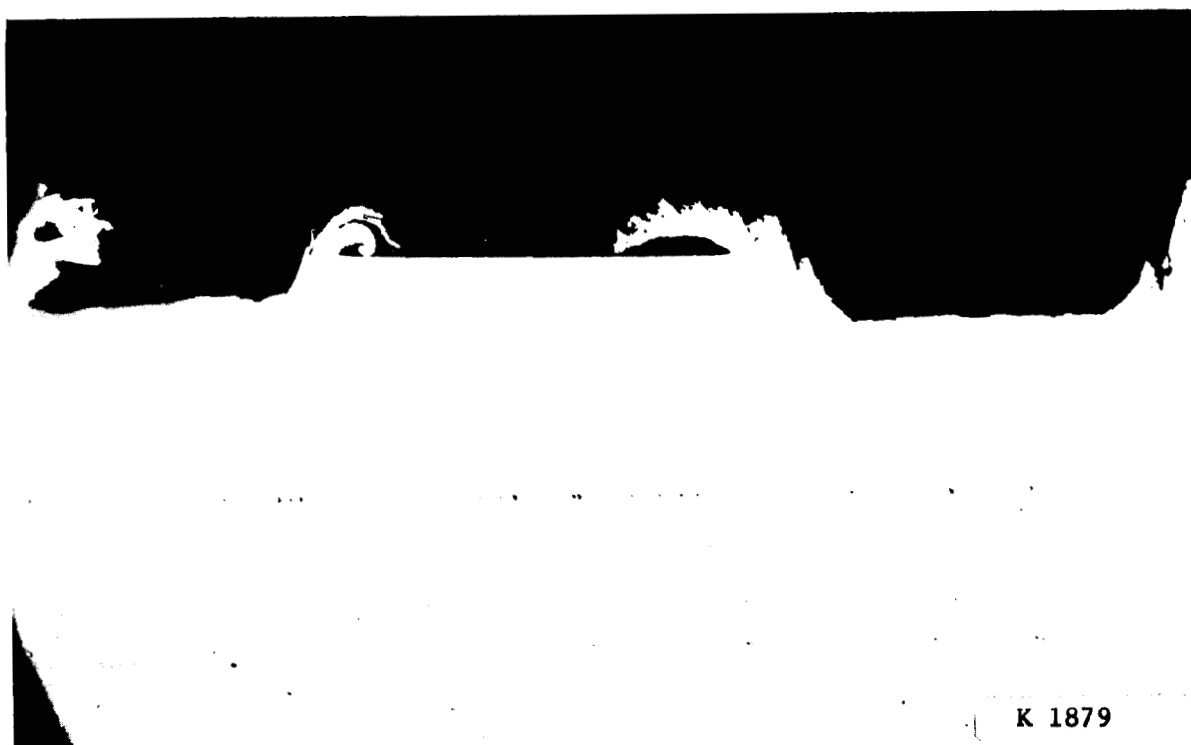
Figure B-6. Silver Electroplated Rub Specimen, Cross Section of Two Grooves, 50X (K 1879)

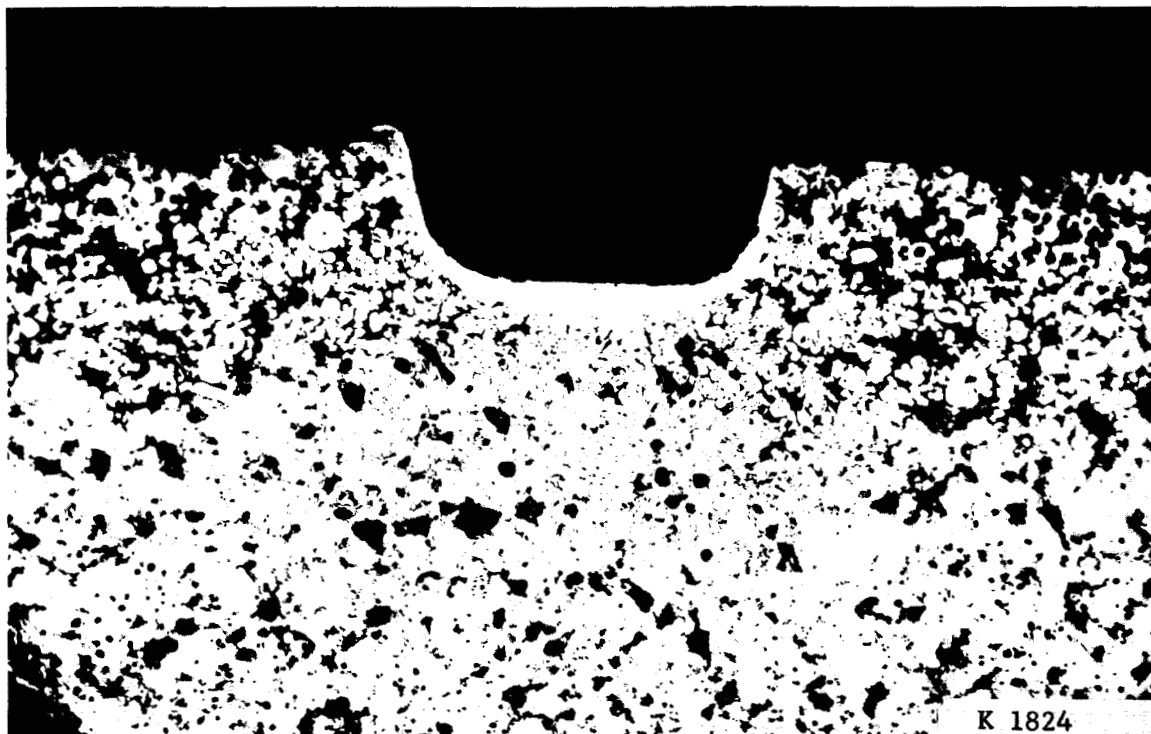
Figure B-7. Copper Foam After Labryinth Wheel Contact, 50X (K 1824)

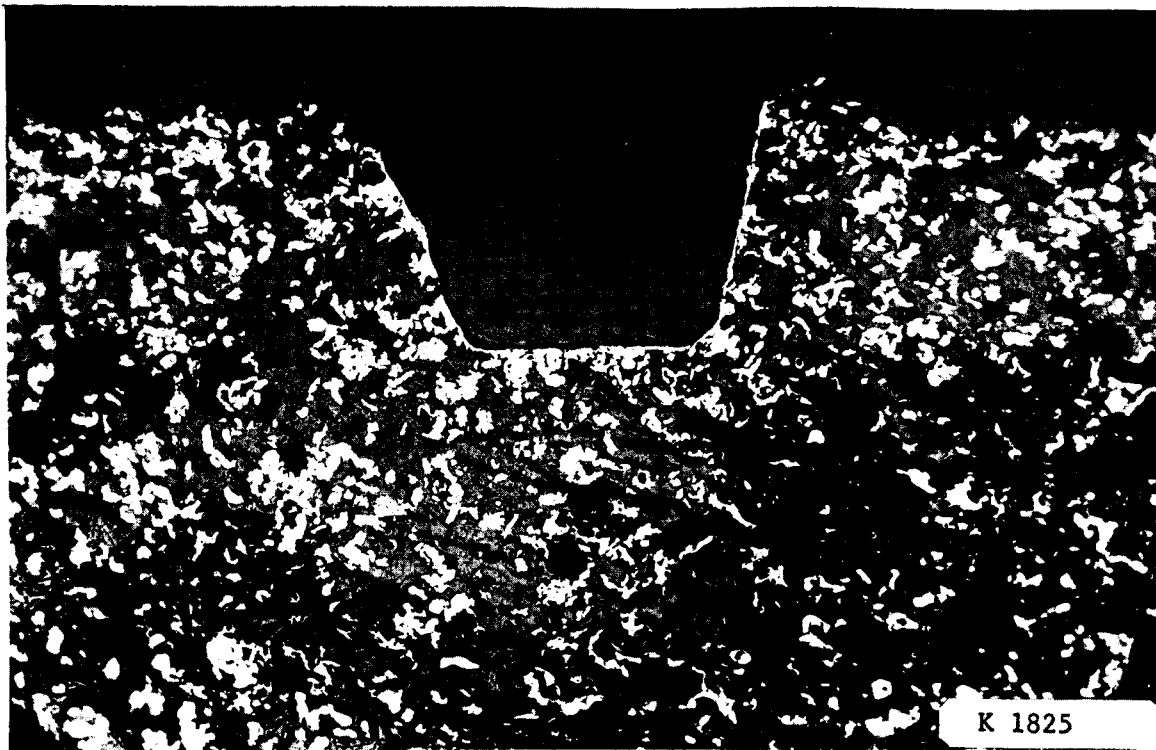
Figure B-9. Nickel Foam After Labryinth Wheel Contact (K 1825)

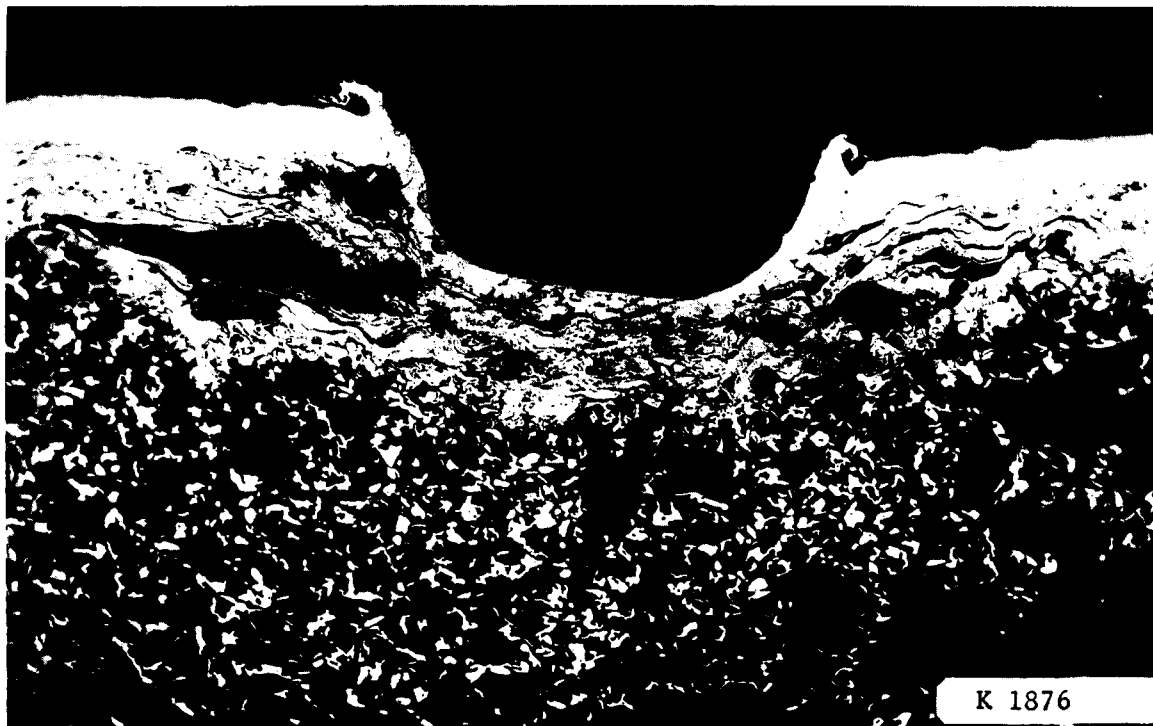
Figure B-10. Nickel Foam Crusted with Nickel Sprayed Metal and Electroplated Nickel (K 1876)
